TECHNICAL INSPECTION REPORT

OPERATION CROSSROADS. U.S.S. INDEPENDENCE (CVL 22)

TEST ABLE.

VOLUME 2 OF 4 [10]

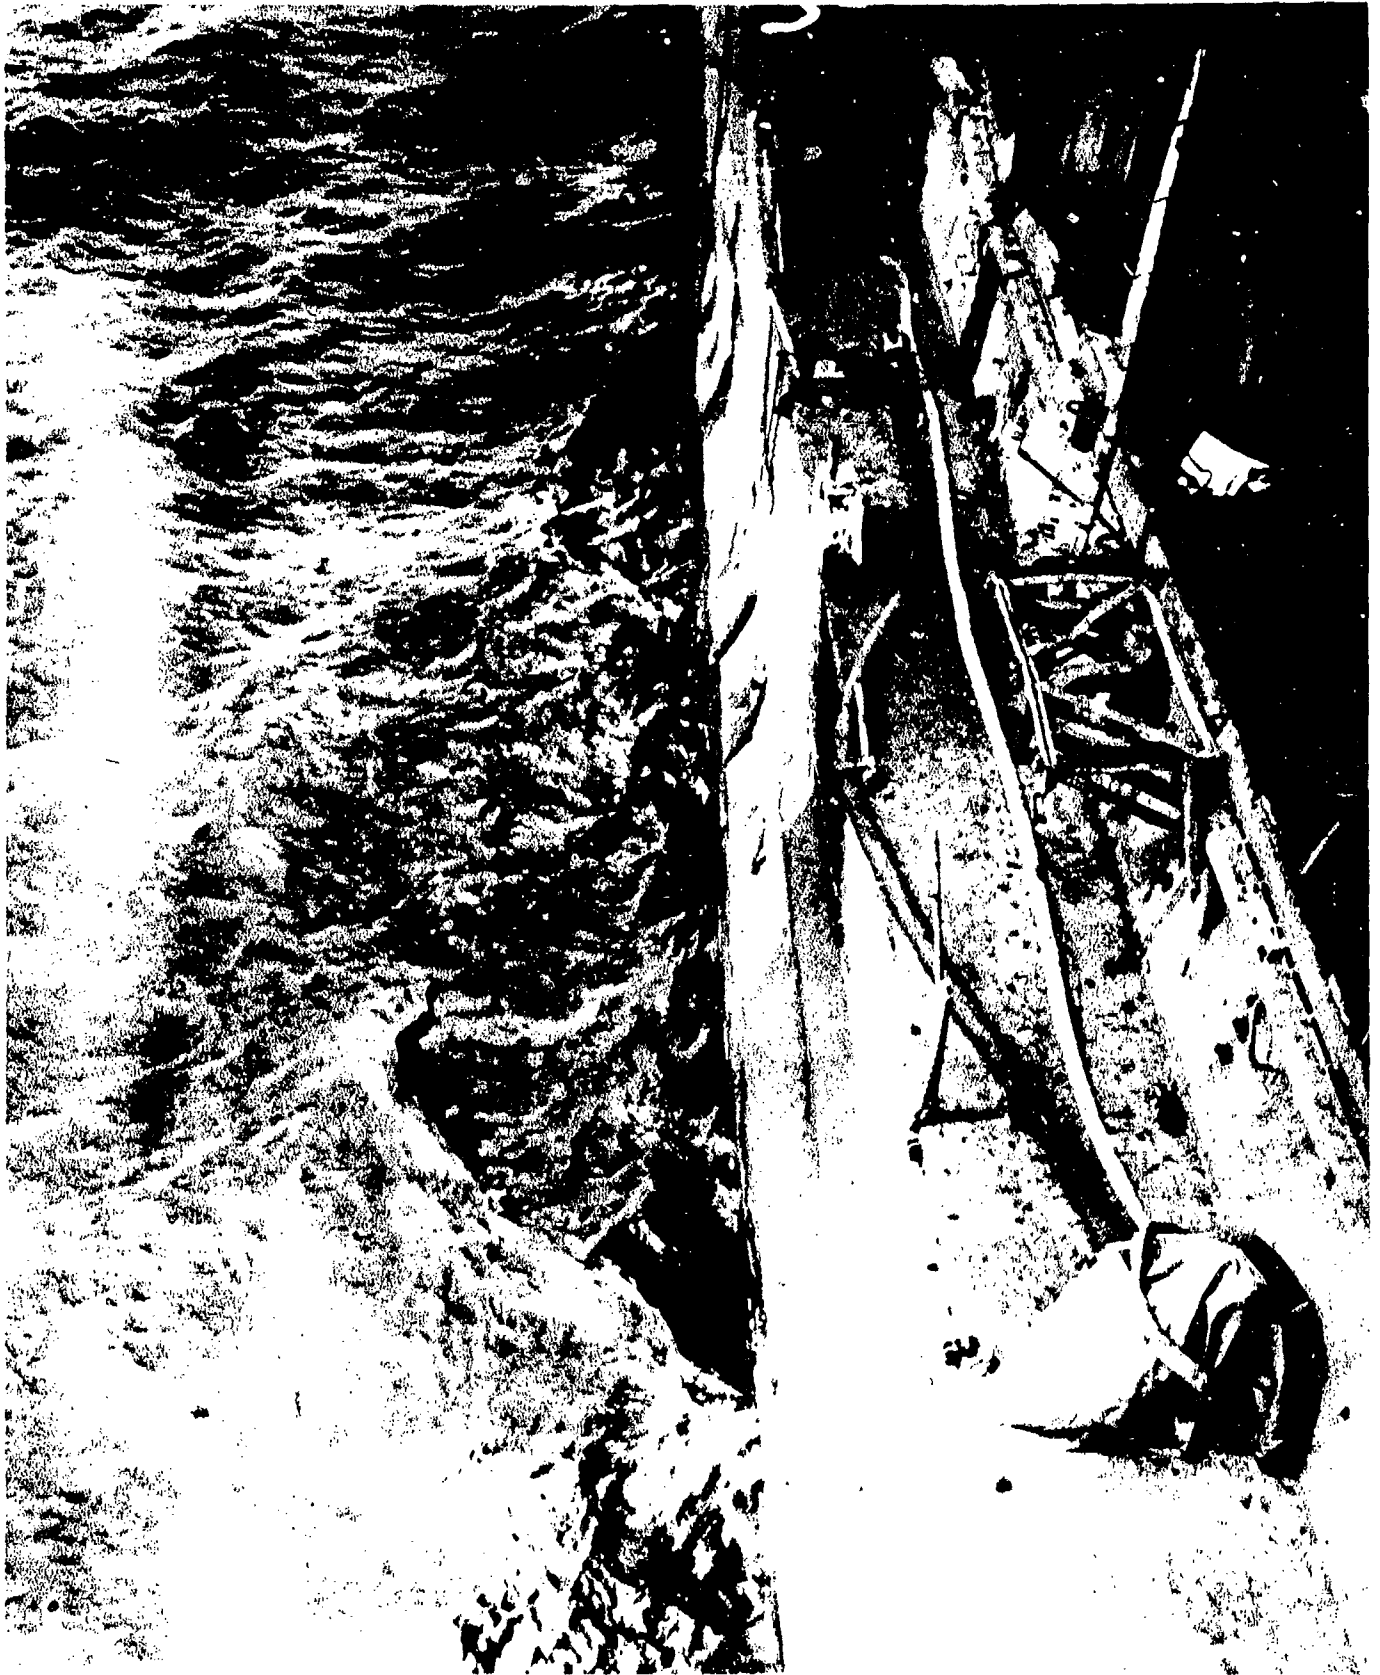
AA-CR-59-2166-5. General view of damage to port side between frames 75 and 88 looking forward. For view looking aft see 2166-4.

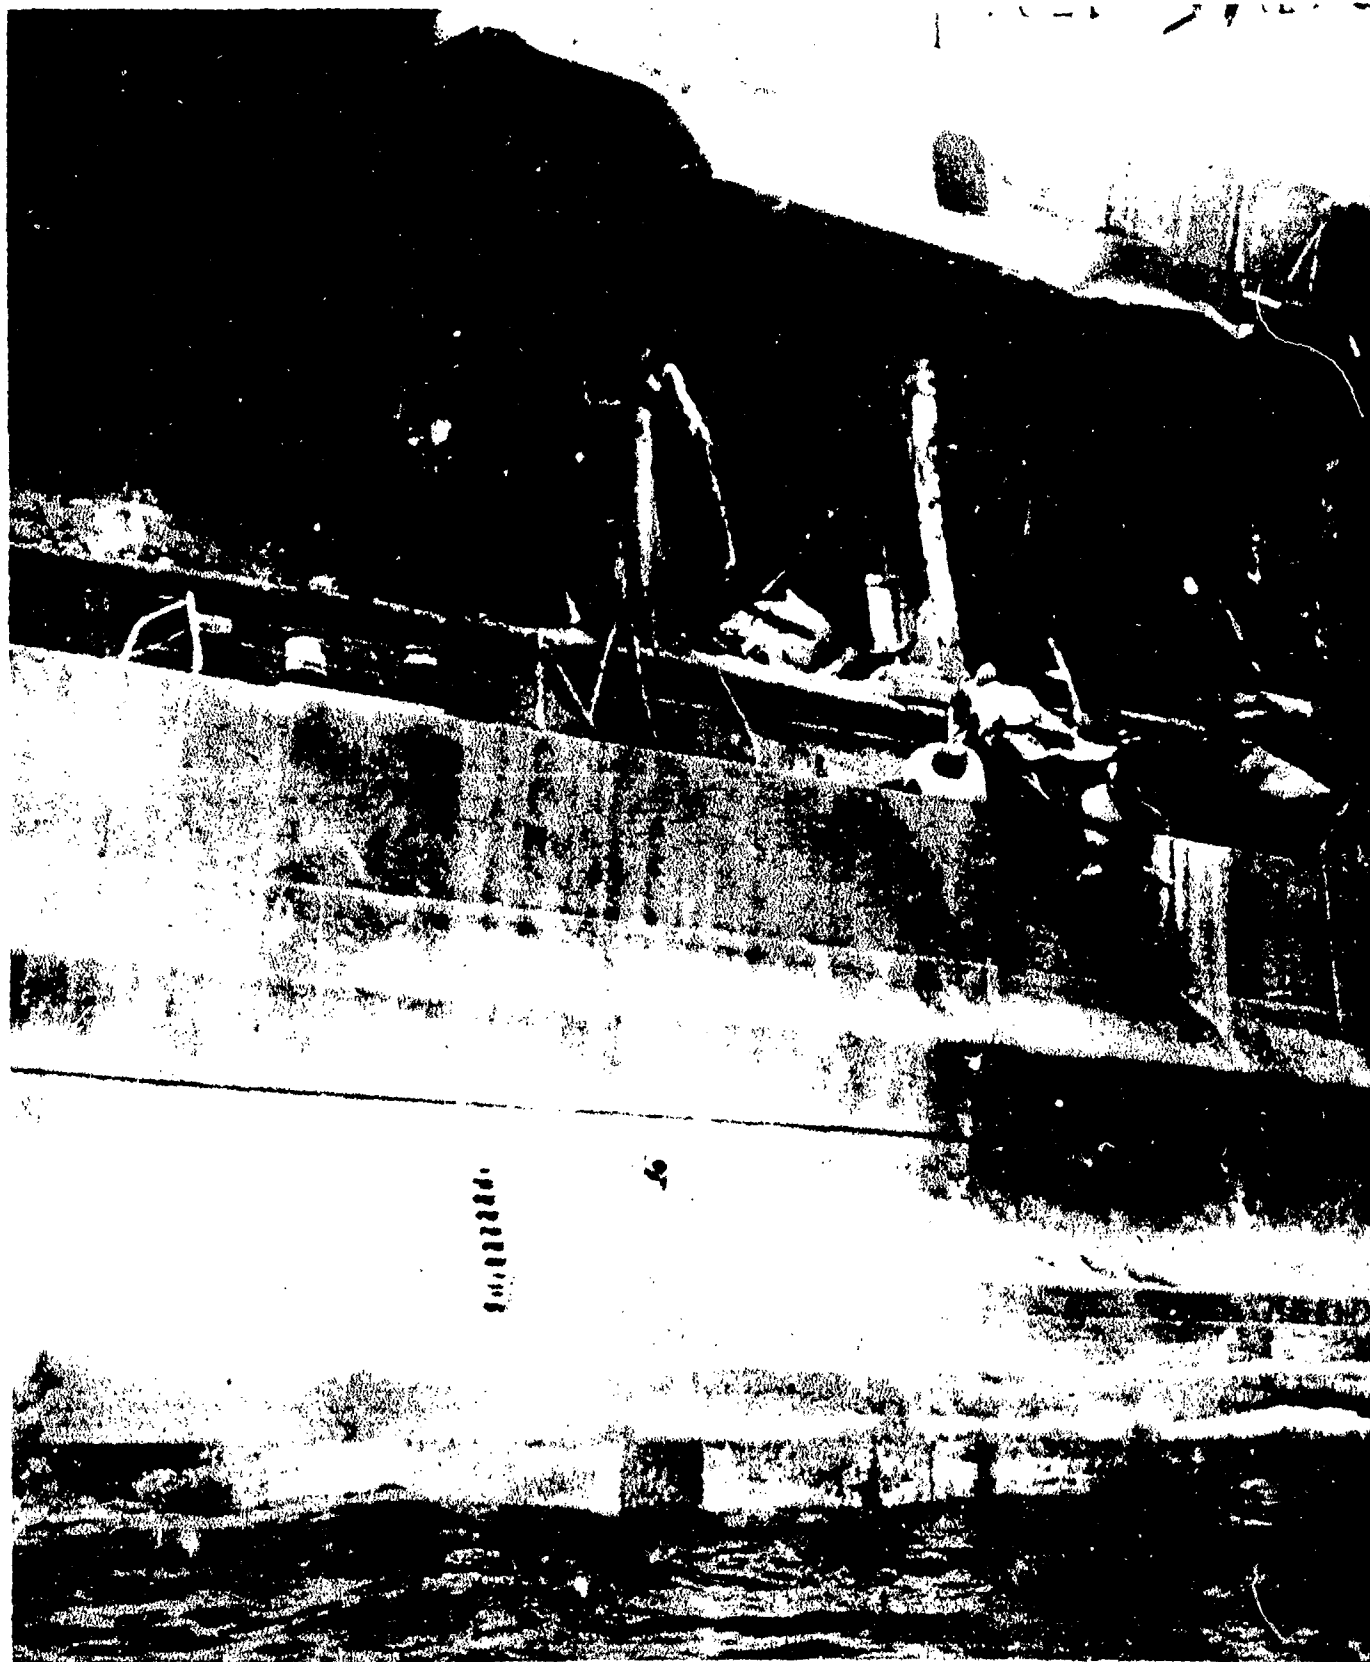
AA-CR-65-1734-9. General view of damage to port side between frames 71-88. Note heavy dishing of hangar side plating frames 71-74; and, deformation of columns to flight deck bents. Bitts are at frame 74.

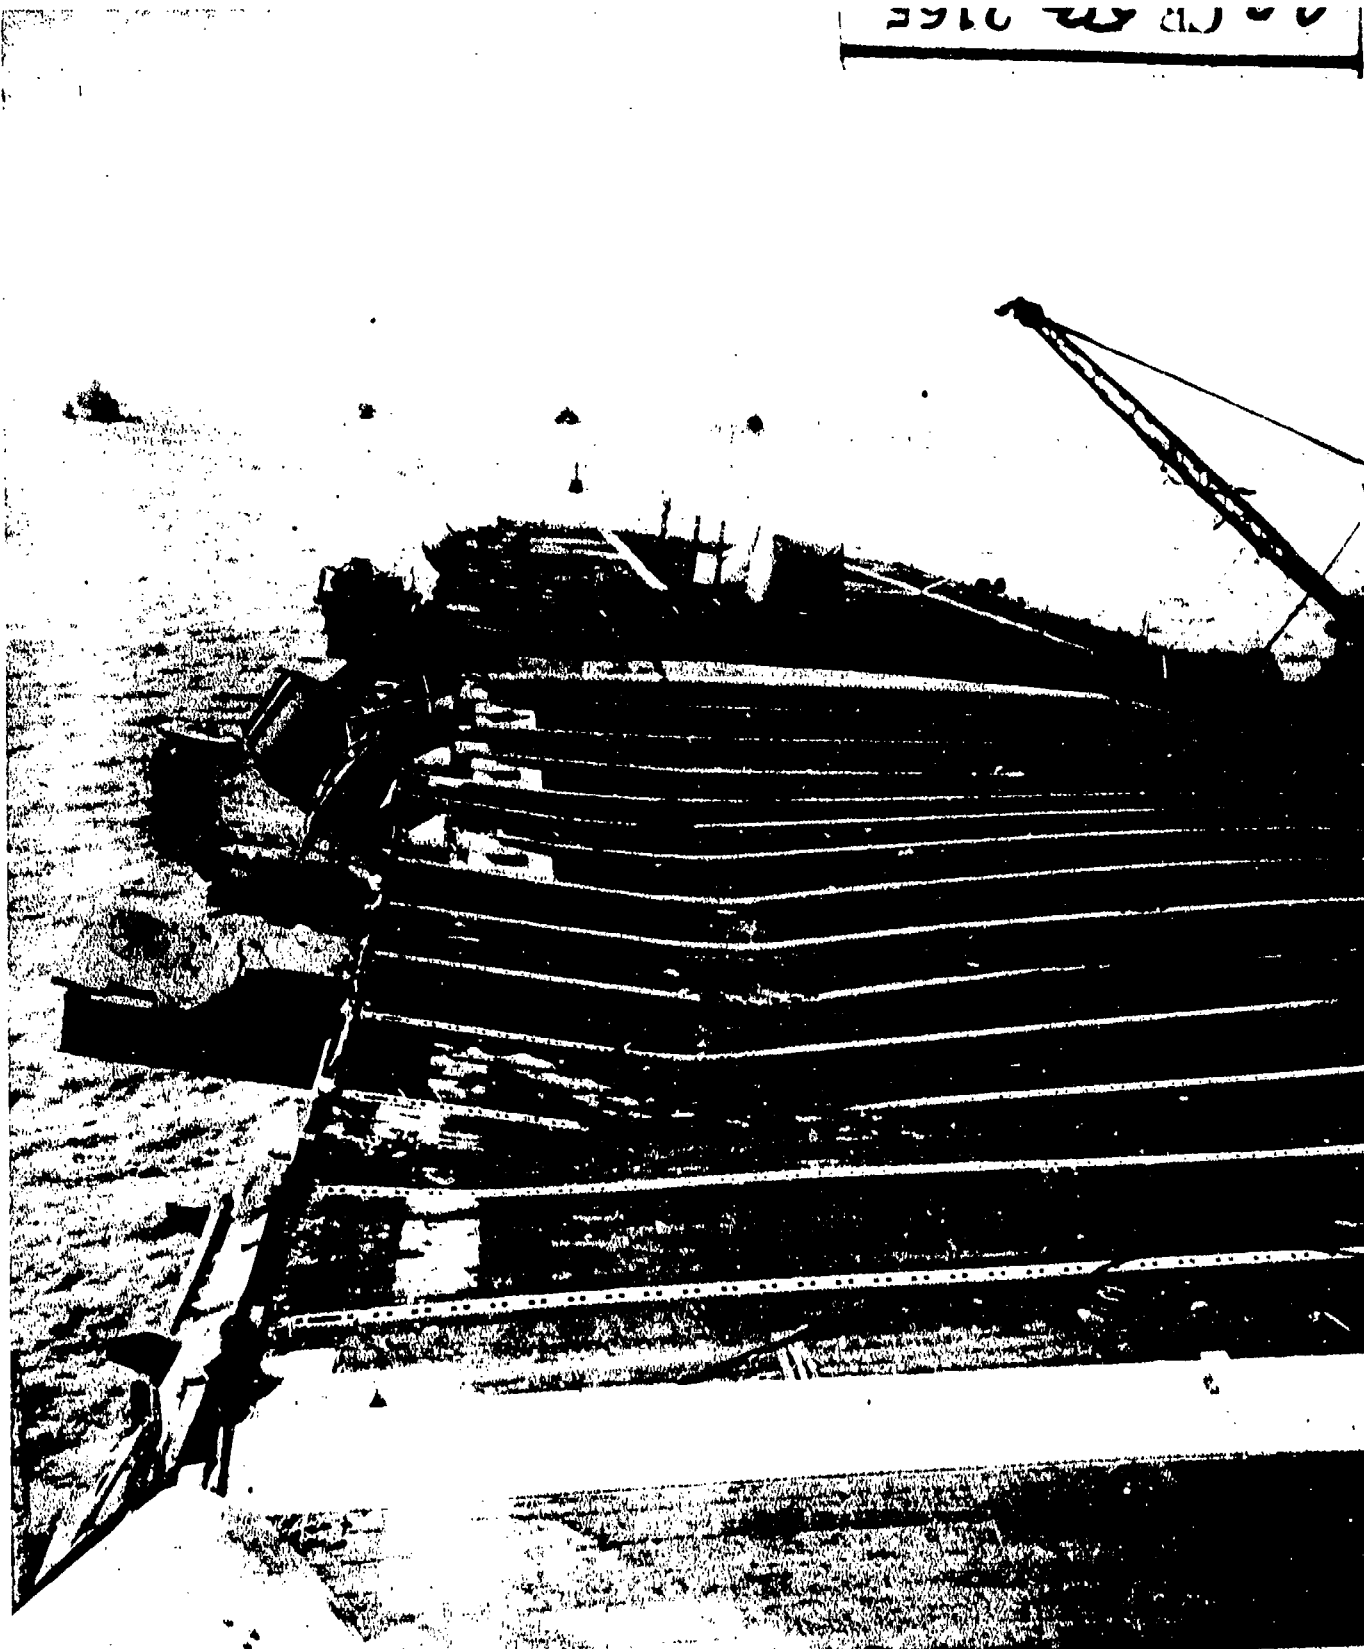
AA-CR-59-2165-10. Damaged port gallery walkway and sponsons, frames 64 to 77.

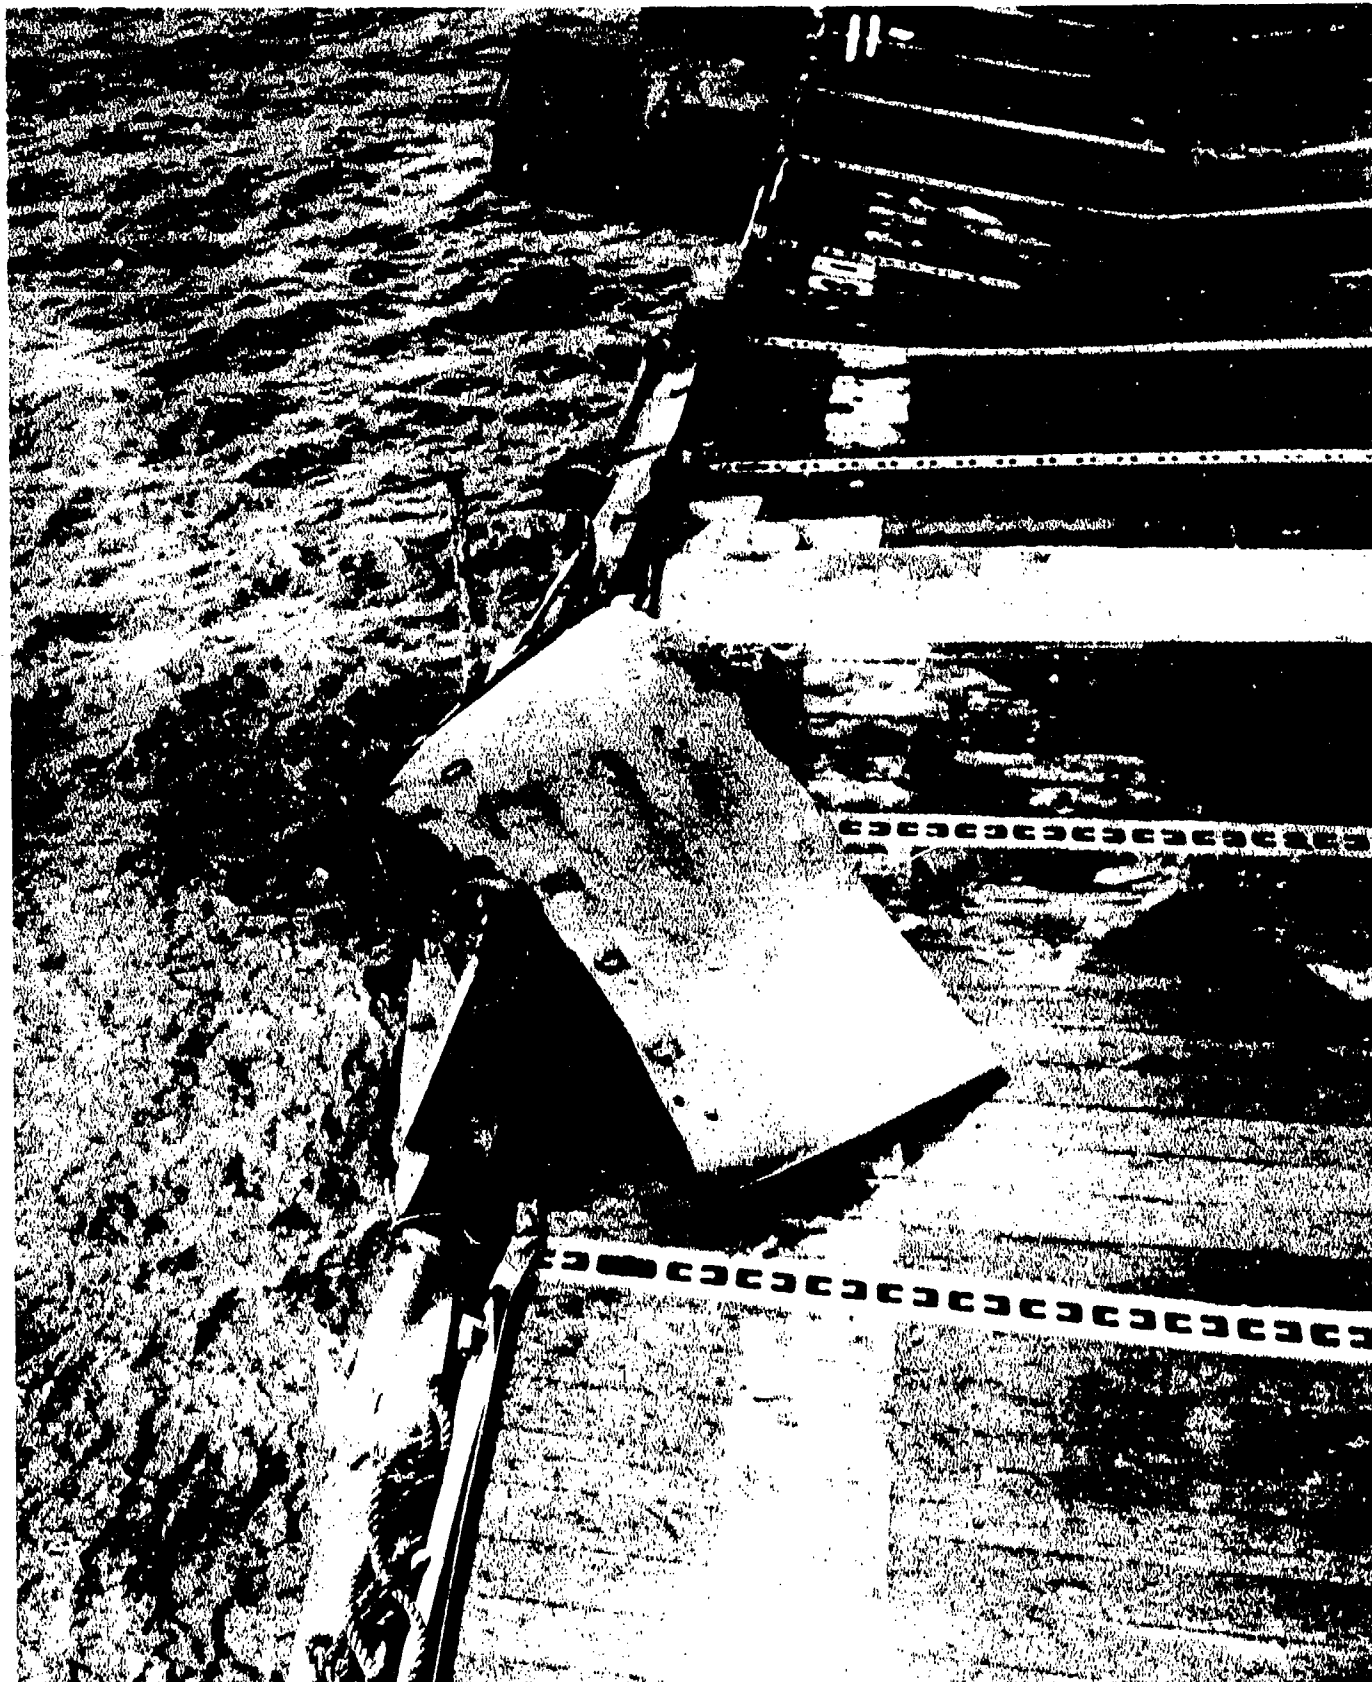
AA-CR-59-2165-11. Damaged gallery walkway and sponsons, port side, frames 68 to 88. Looking forward.

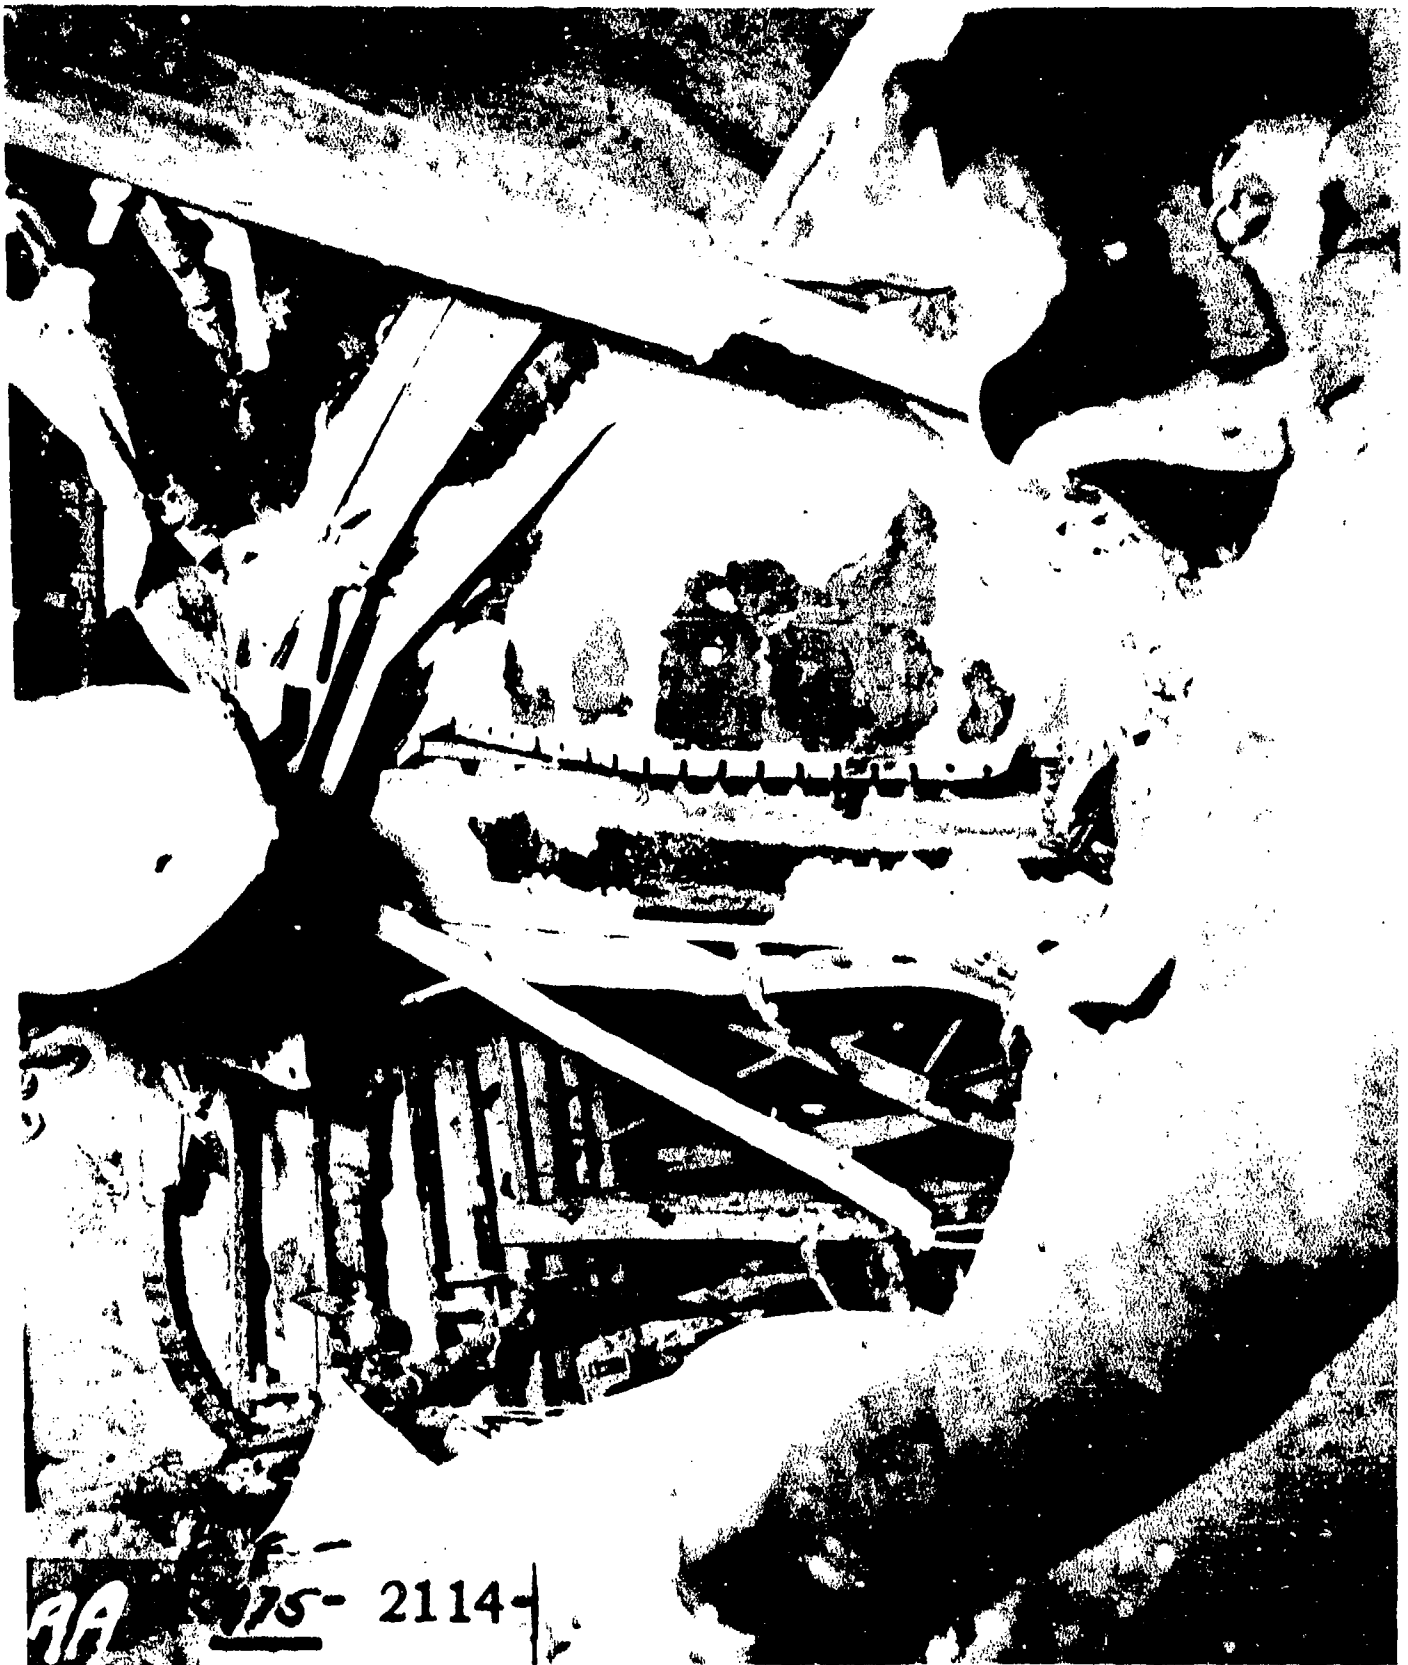
AA-CR-175-2114-5. Damage in crews shelter as seen from gallery door, port catwalk, frame 134.

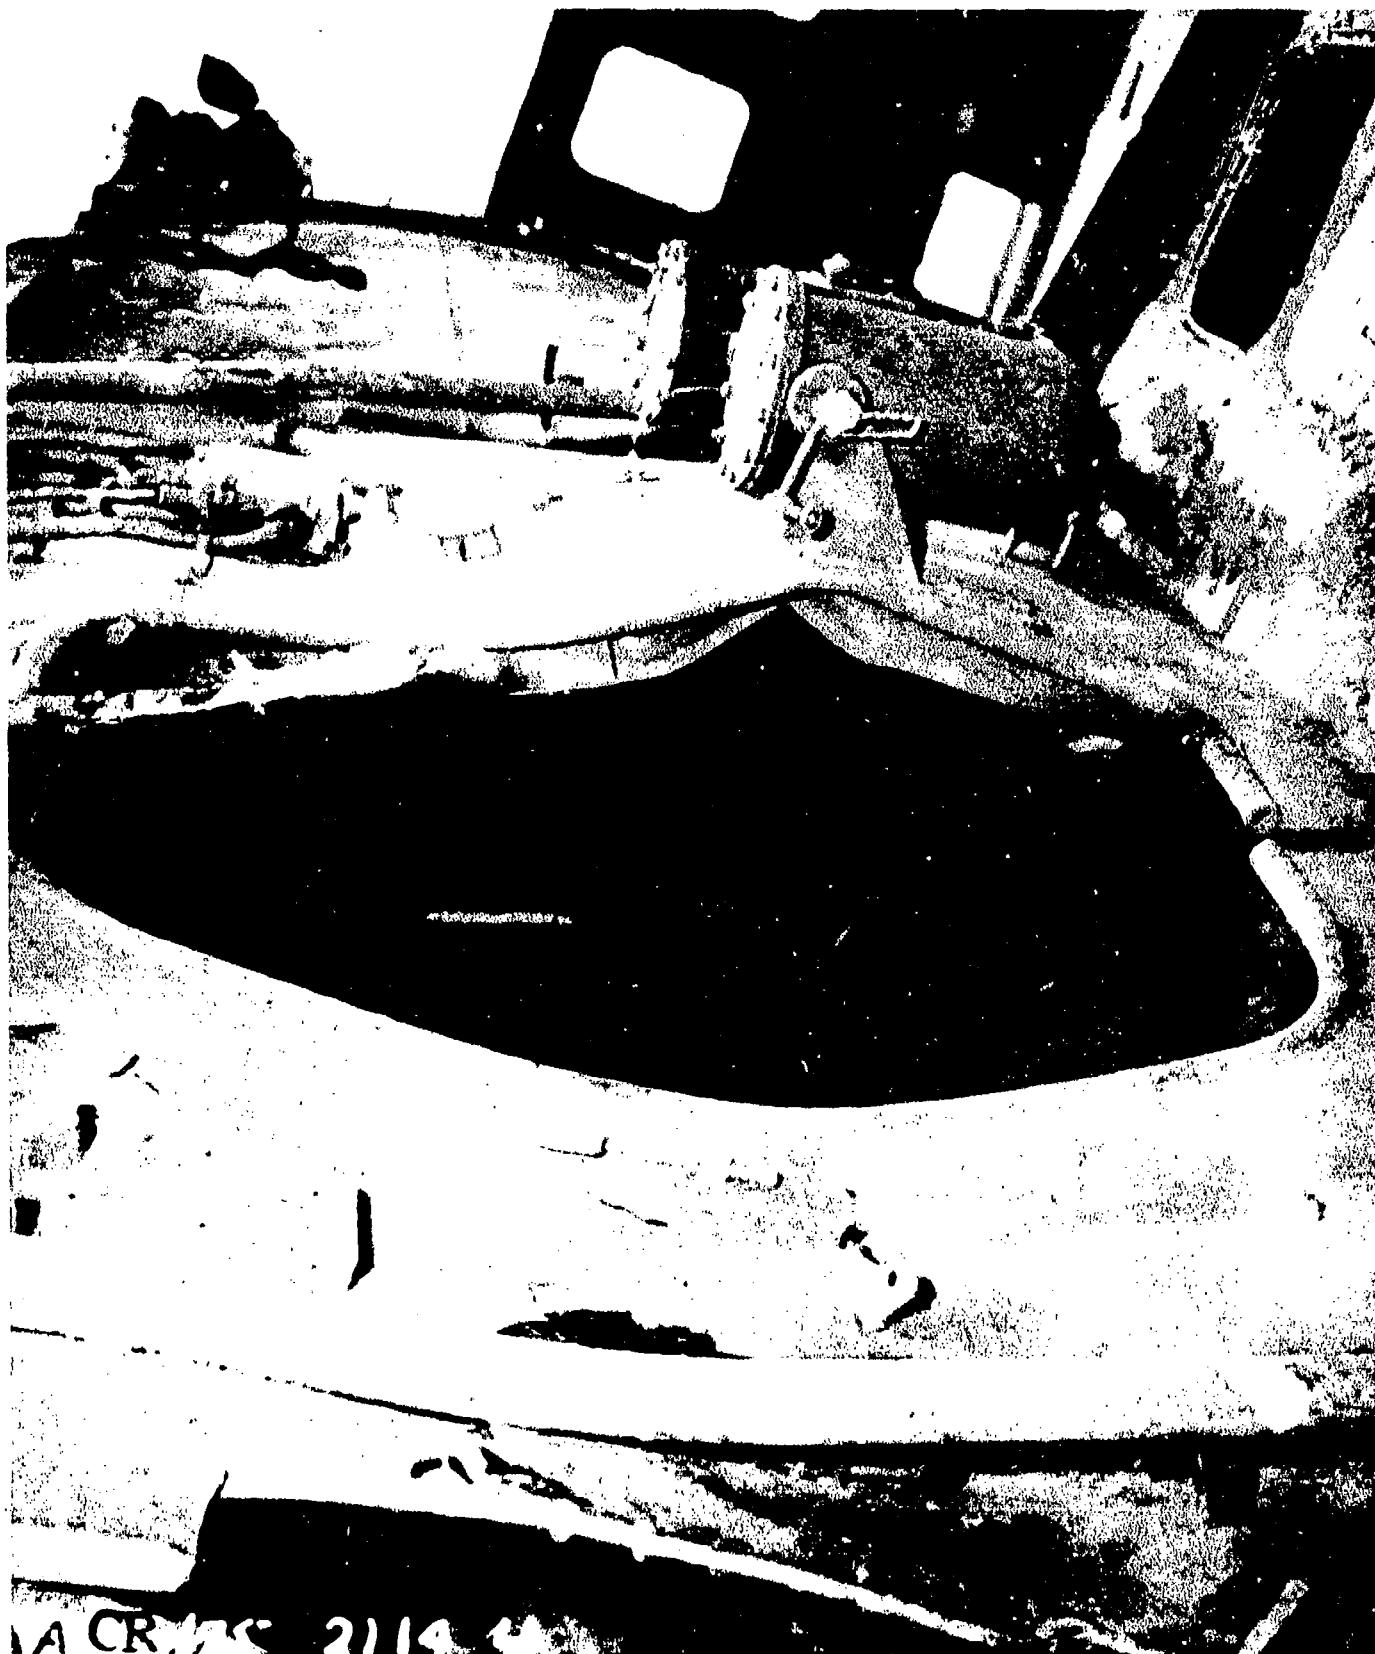
AA-CR-175-2114-4. Damage to gallery walkway and entrance to crew's shelter, frame 134, port side.

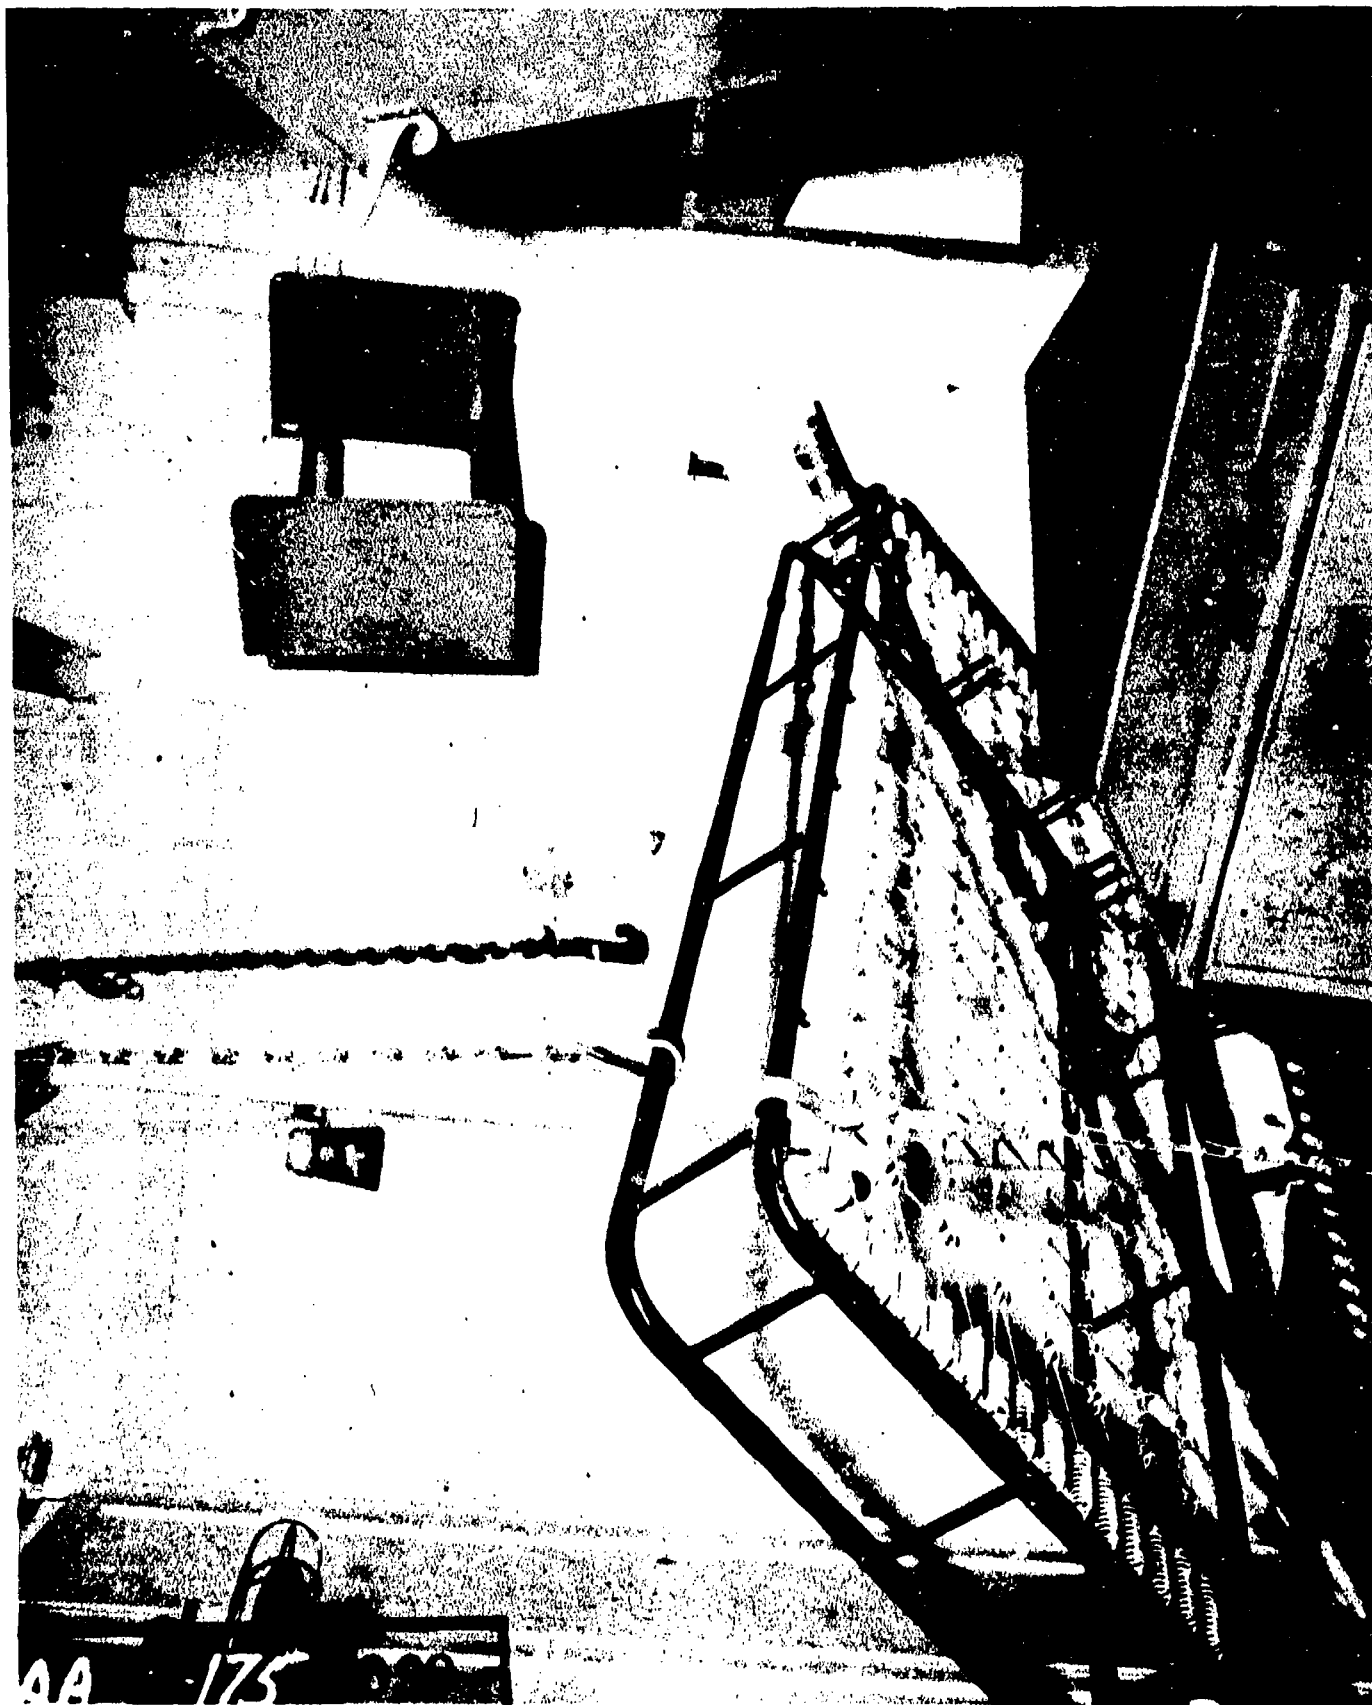
AA-CR-175-2039-11. Looking aft into stateroom 0301, starboard side, frame 37. Shock damage.

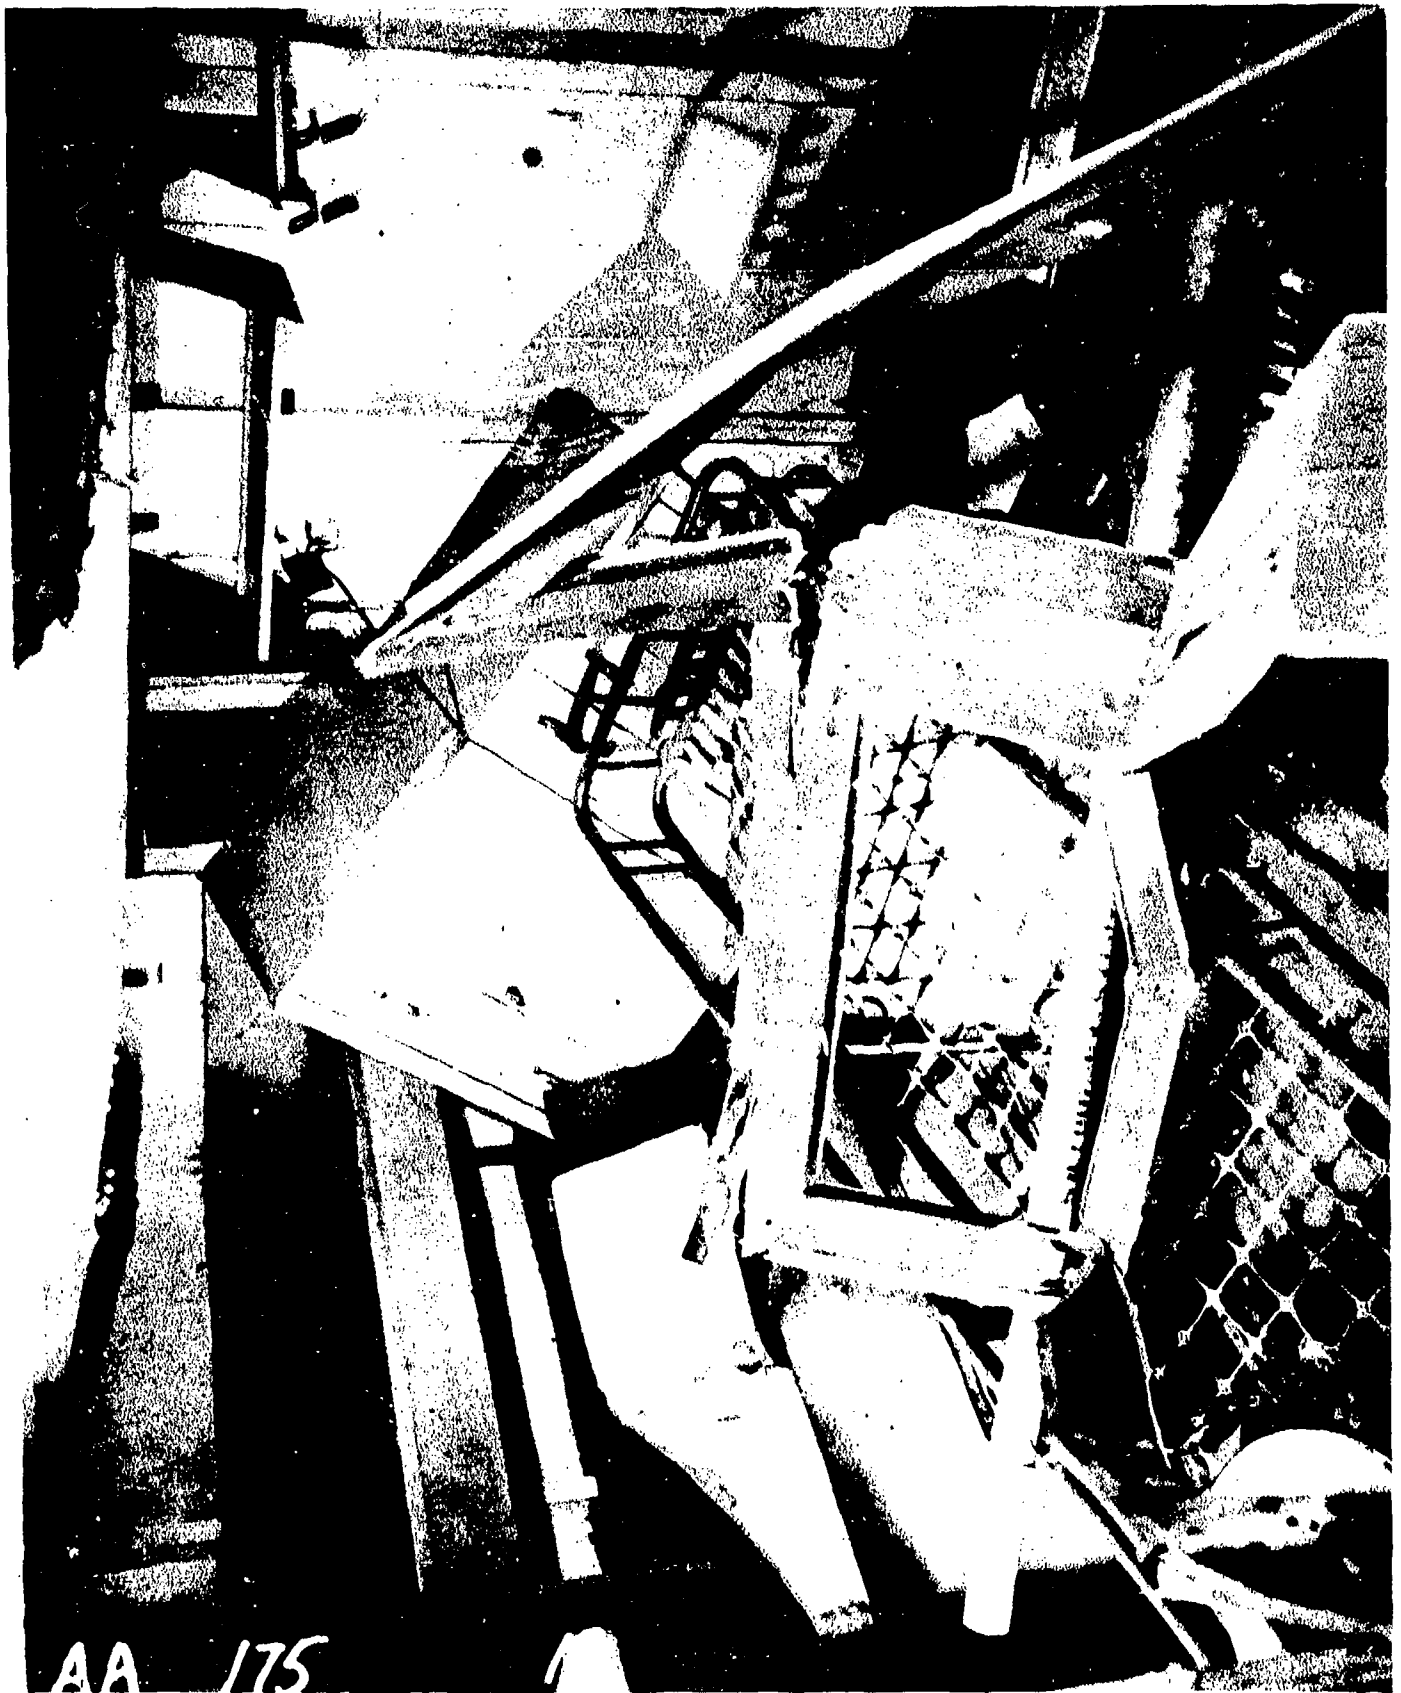
AA-CR-175-2039-10. Gallery deck, looking aft and inboard into state-room 0310, frame 37, port side, showing shock damage to joiner bulk-head, bunks and furniture.
